TECHNICAL REPORT H-77-22

BREAKWATER STABILITY STUDY IMPERIAL BEACH, CALIFORNIA

Hydraulic Model Investigation

Prepared for U. S. Army Engineer District, Los Angeles
Los Angeles, California 90053

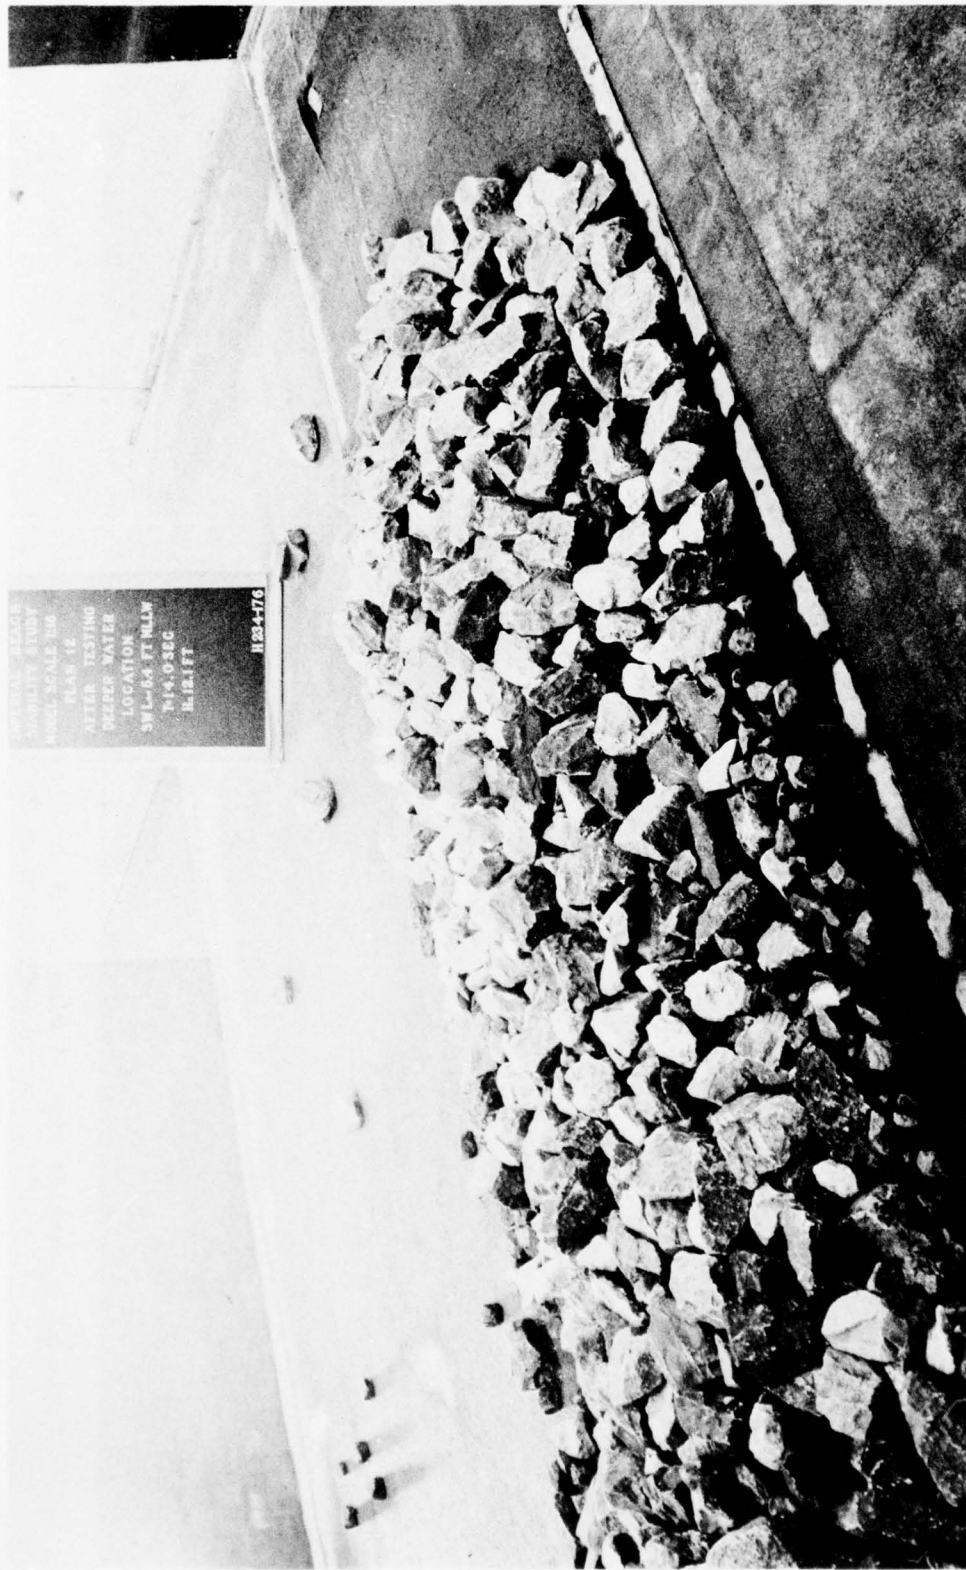
Photo 64. Sea-side view of high-sill section of Plan 12 in the deeper water location after 4.0 hr of 14.0-sec, 12.1-ft waves at an swl of +5.4 ft mllw

28. Plan 12 (Plate 17 and Photo 60) was a repeat test for the high-sill section and low-sill trunk of Plan 11. The alternating high and low sills of Plan 11 were reversed during construction of Plan 12 so that a 1V-on-3H slope high-sill head could be constructed at the end of the 1V-on-2H slope high-sill trunk. Construction of the high-sill head was identical with Plan 8 (paragraph 22) except that in Plan 8 the head had been attached to a high-sill trunk with 1V-on-3H slopes. Crown elevations were identical with those of Plan 11. After 1.0 hr of exposure to 14.0-sec, 8.3-ft waves at an swl of 0.0 ft mllw, the structure had experienced very minor damage (Photo 61). The test condition was changed to 14.0-sec, 12.1-ft waves at an swl of +5.4 ft mllw and after 2.0 hr of wave attack, only minor damage was observed (Photo 62). The identical test conditions were extended and after a total of 4.0 hr of wave attack the breakwater had accrued minor to moderate damage (Photos 63-65).

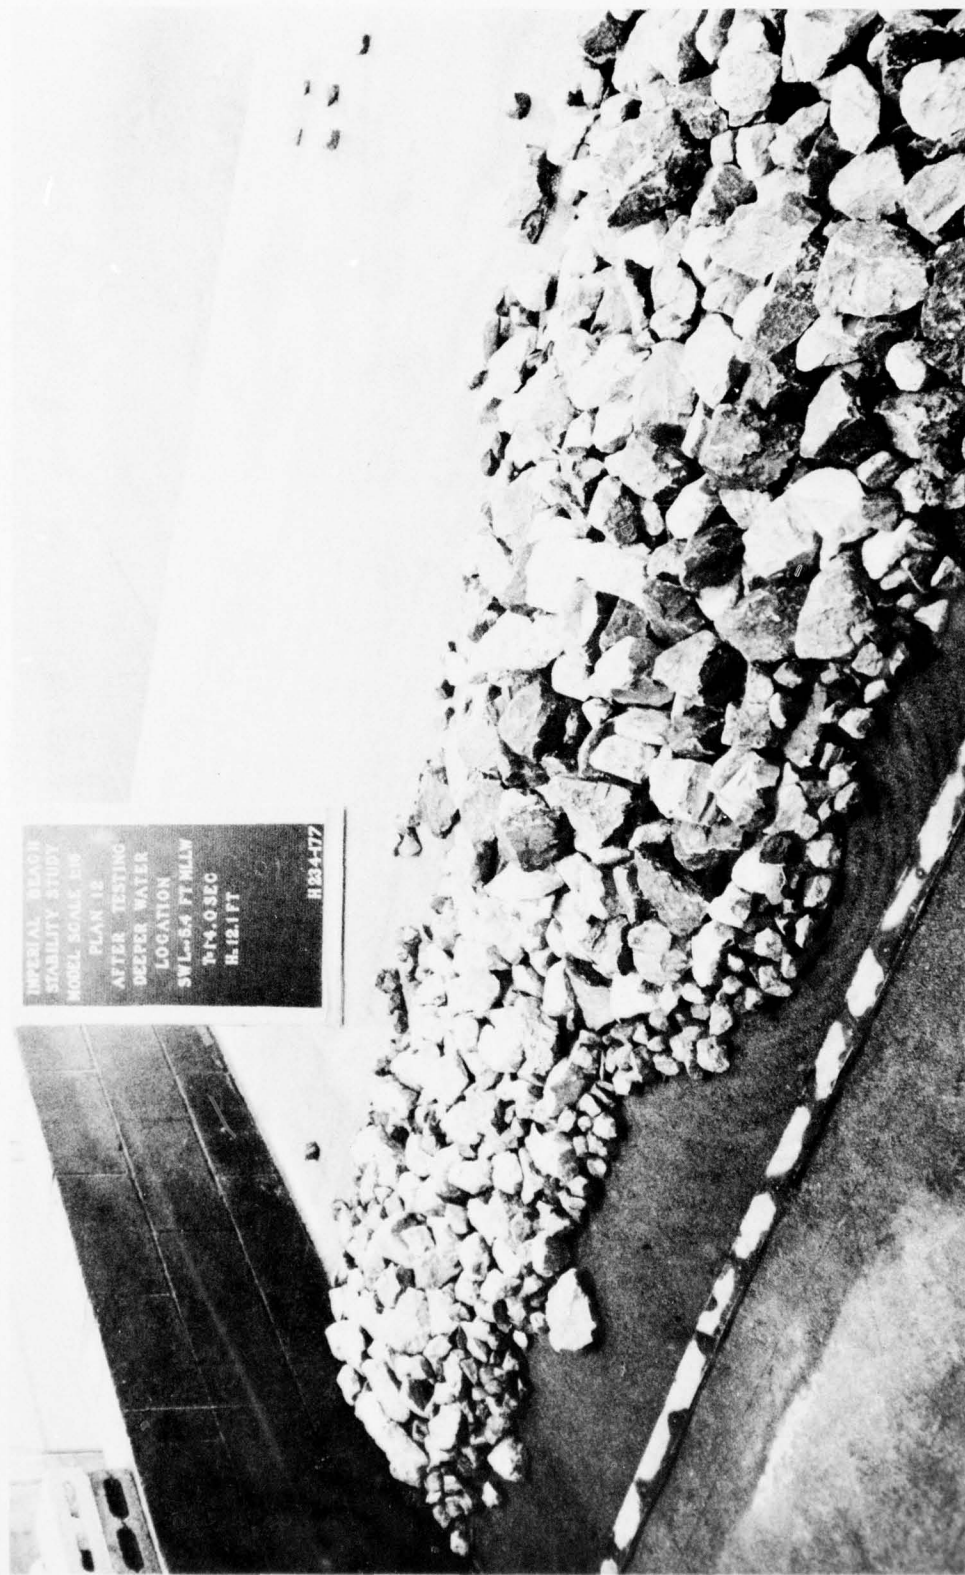
Photo 65. Sea-side view of low-sill section of Plan 12 in the deeper water location after
4.0 hr of 14.0-sec, 12.1-ft waves at an swl of +5.4 ft mllw

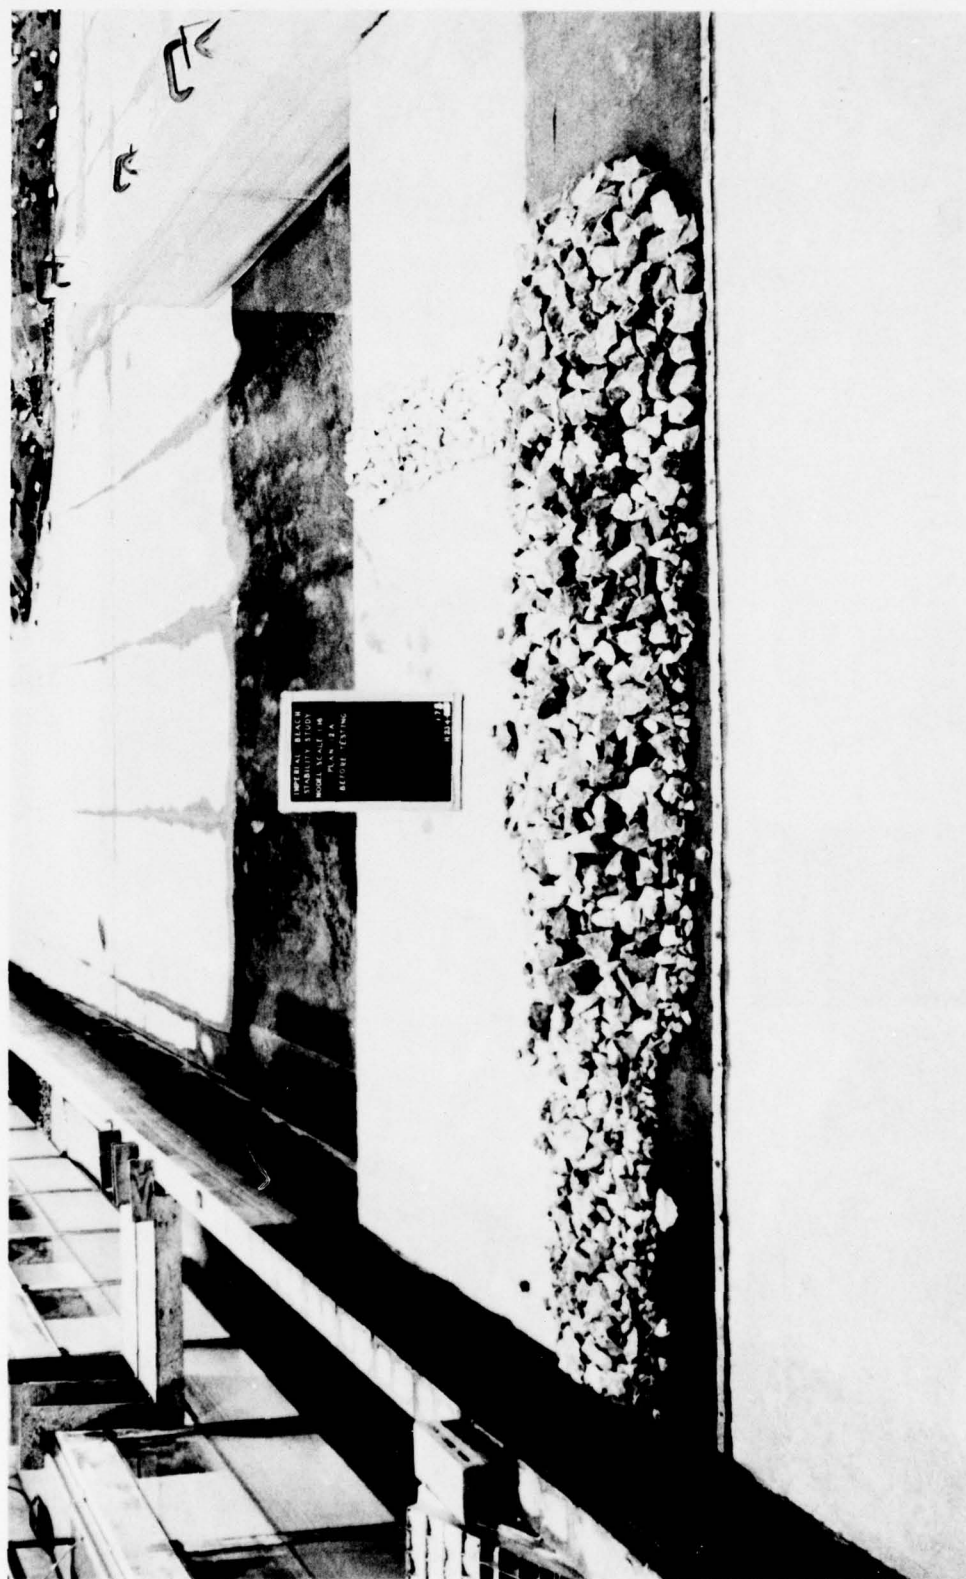
Photo 66. Sea-side view of Plan 12A before wave attack

29. Plan 12A (Plate 18 and Photo 66) consisted of rebuilding the high-sill head and adding a 5-ft-high, beach-connected groin to Plan 12. The groin was constructed with 1V-on-2H slopes using 5.0-ton graded armor stone and connected at a 90° angle to the beach side of the high-sill head. In order to observe the effect of extended wave attack on the high-sill and low-sill trunk, these sections of the Plan 12 breakwater were not rebuilt before testing was initiated on Plan 12A. After 2.0 hr of attack by 14.0-sec, 12.1-ft waves at an swl of +5.4 ft mllw caused minor damage on the high-sill head and groin. Little change occurred to those portions of the structure which were not rebuilt after testing Plan 12 (Photos 67-69). The breakwater was then exposed to 1.0 hr of 14.0-sec, 8.3-ft waves at an swl of 0.0 ft mllw to check for any possible stability problems on the 5-ft-high groin when exposed to this low-water wave attack. No instability was observed on the groin and the remainder of the breakwater showed very little change.

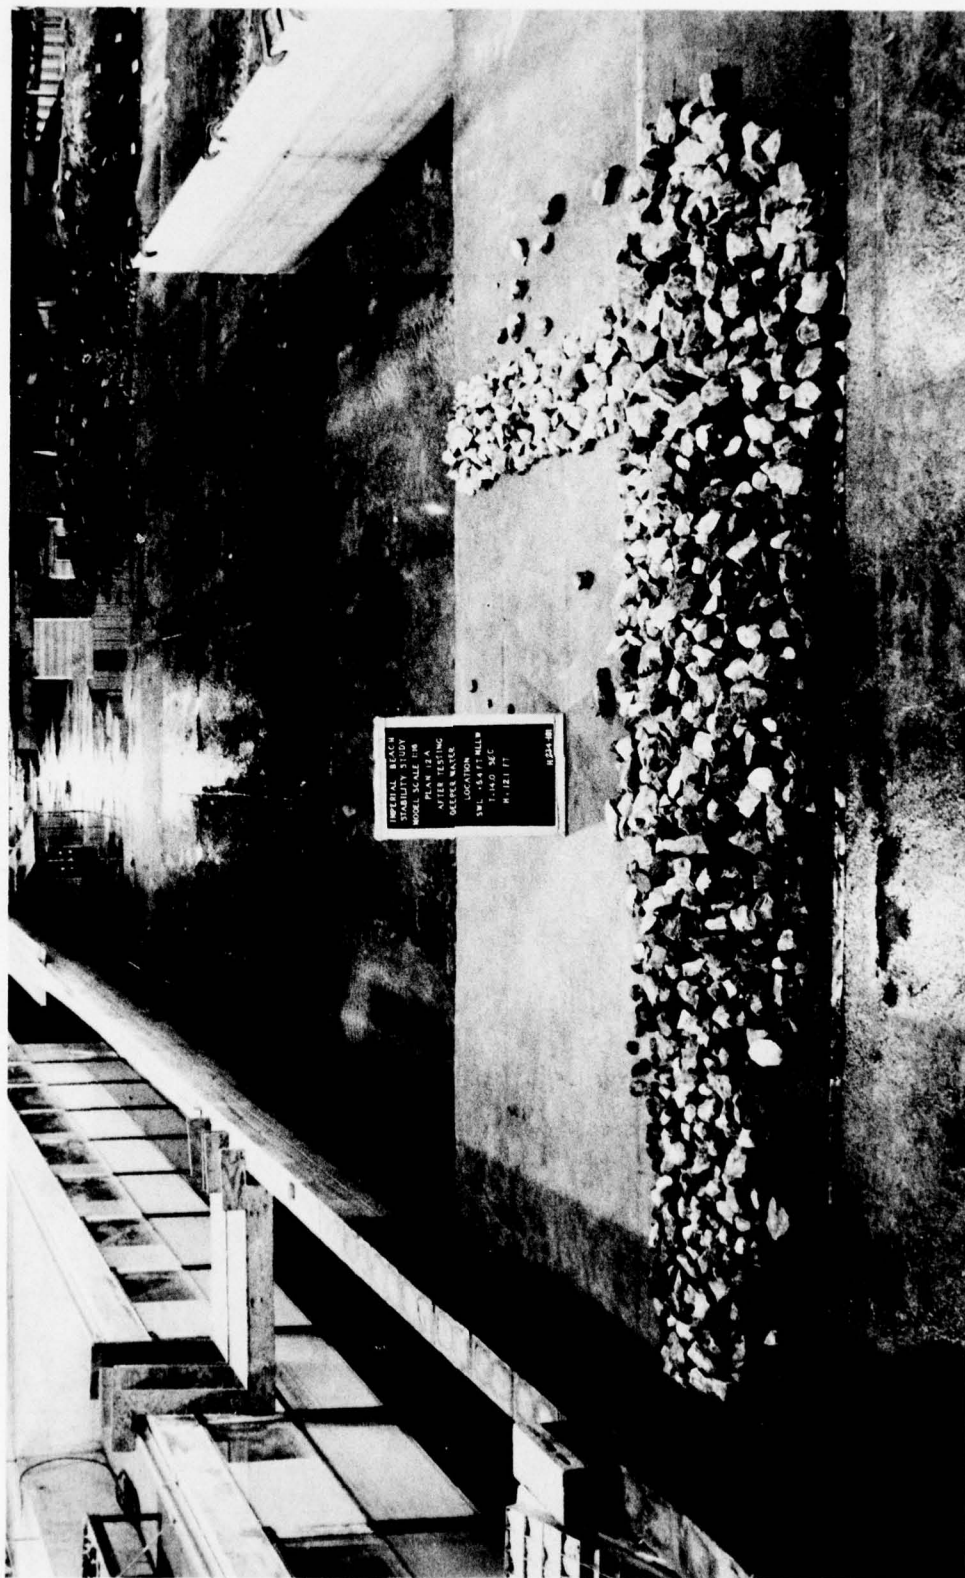
Photo 67. Sea-side view of Plan 12A in the deeper water location after 2.0 hr on high-sill head and 5-ft-high groin and 6.0 hr on remainder of breakwater of 14.0-sec, 12.1-ft waves at an swl of +5.4 ft mllw

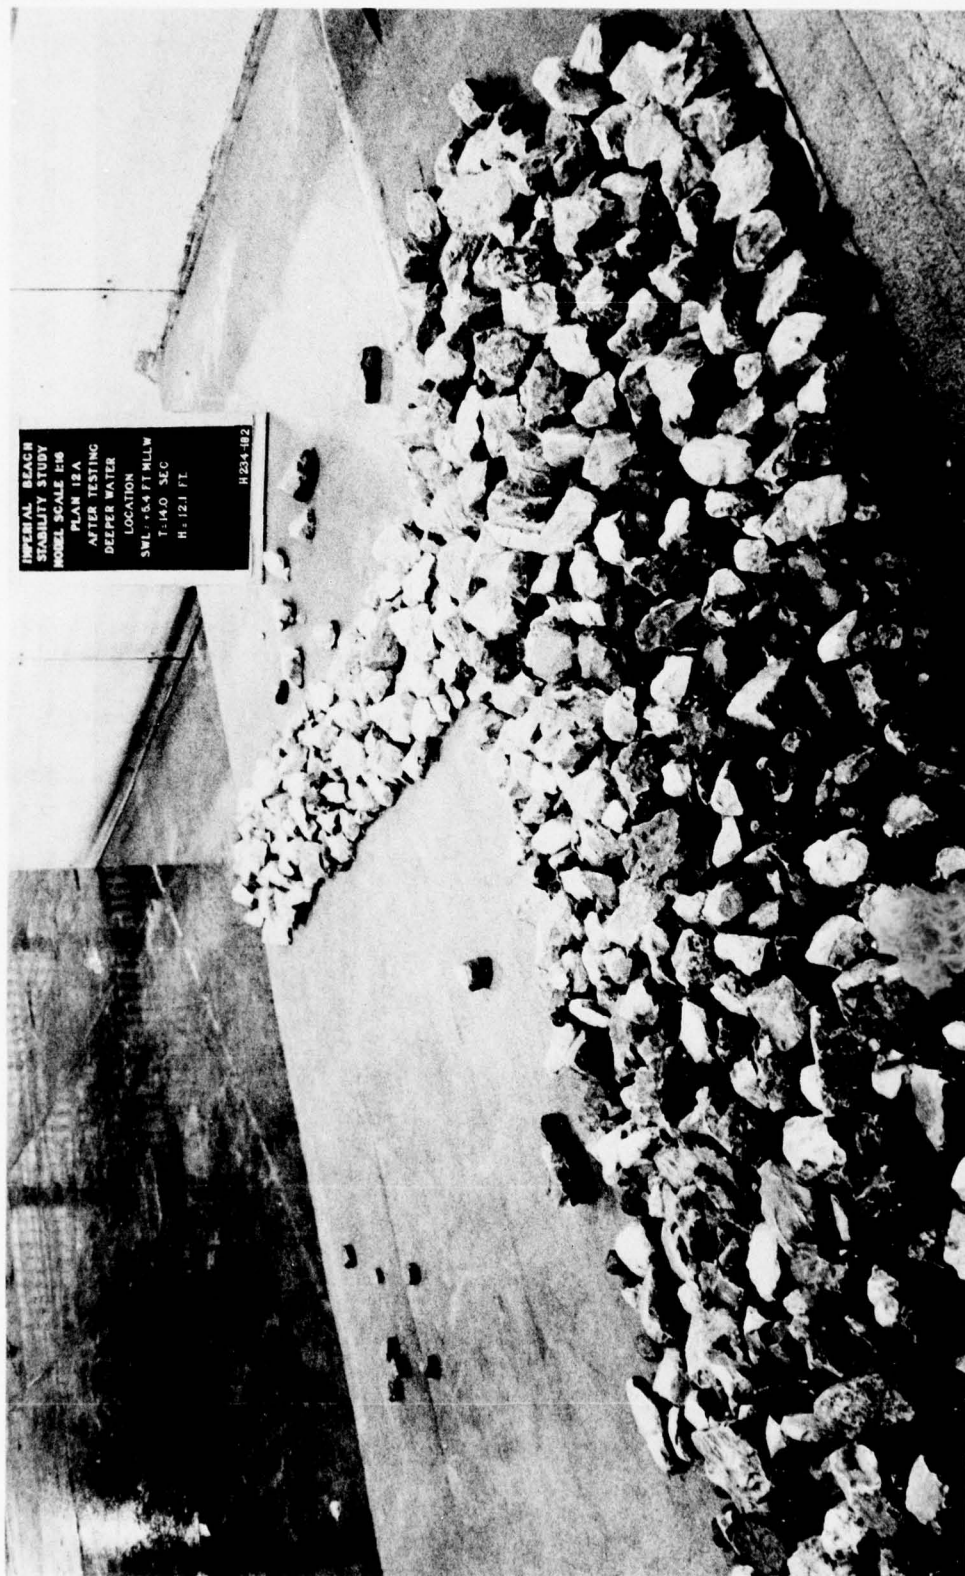
Photo 68. Sea-side view of high-sill section and 5-ft-high groin of Plan 12A in the deeper water location after 2.0 hr on high-sill head and groin and 6.0 hr on remainder of high-sill of 14.0-sec, 12.1-ft waves at an swl of +5.4 ft mllw

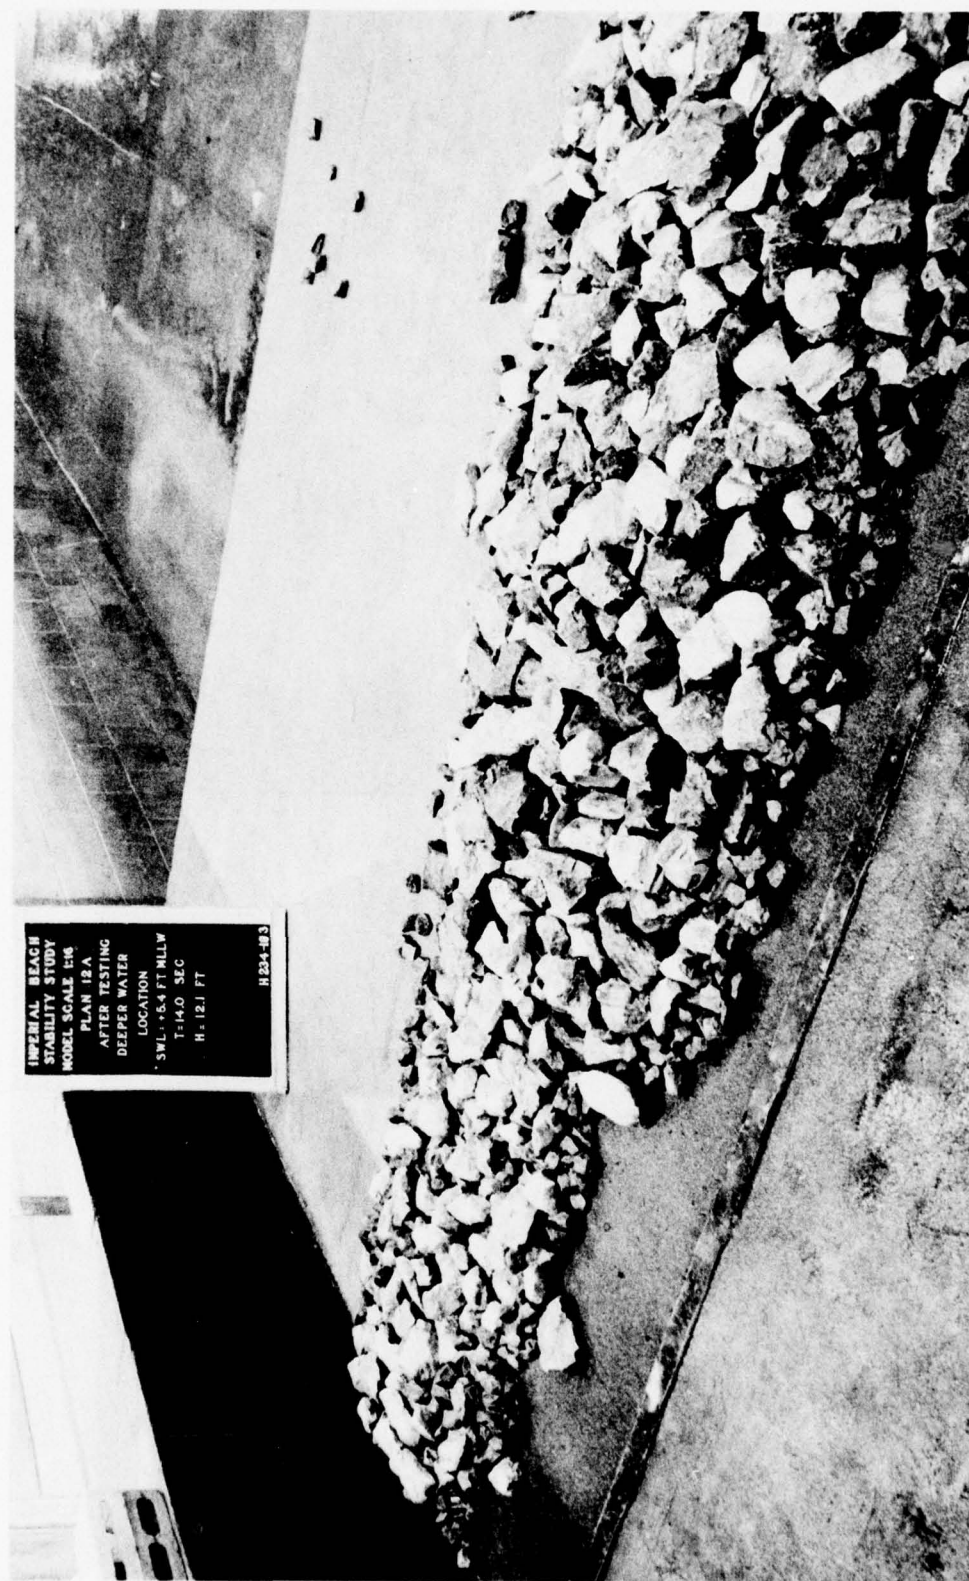
Photo 69. Sea-side view of low-sill section of Plan 12A in the deeper water location after
 6.0 hr of 14.0-sec, 12.1-ft waves at an swl of +5.4 ft mllw

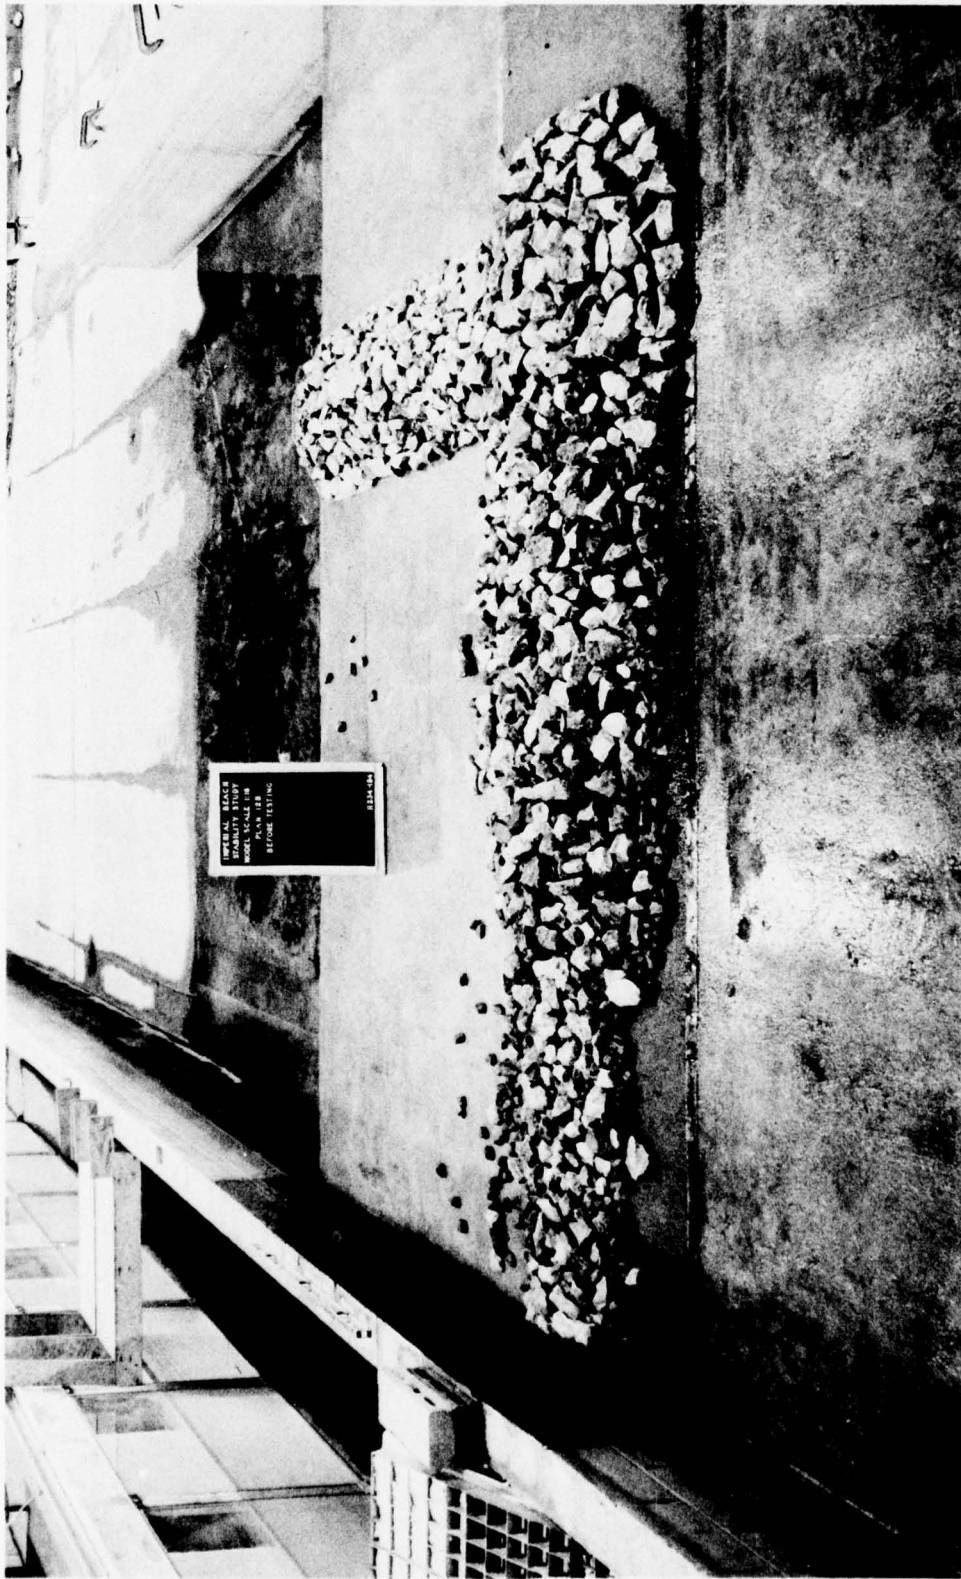
Photo 70. Sea-side view of Plan 12B before wave attack

30. Plan 12B (Plate 19 and Photo 70) consisted of the addition of a 10-ft-high, 5.0-ton graded armor stone, beach-connected groin and rebuilding of the high-sill head on Plan 12A. The remainder of the breakwater, the high- and low-sill trunks, was once again not rebuilt in order to observe the results of extended wave attack. After 2.0 hr of exposure to 14.0-sec, 12.1-ft waves at an swl of +5.4 ft mllw, the intersection between the high-sill head and groin showed significant damage and the remainder of the breakwater showed minor to moderate damage (Photos 71-73).

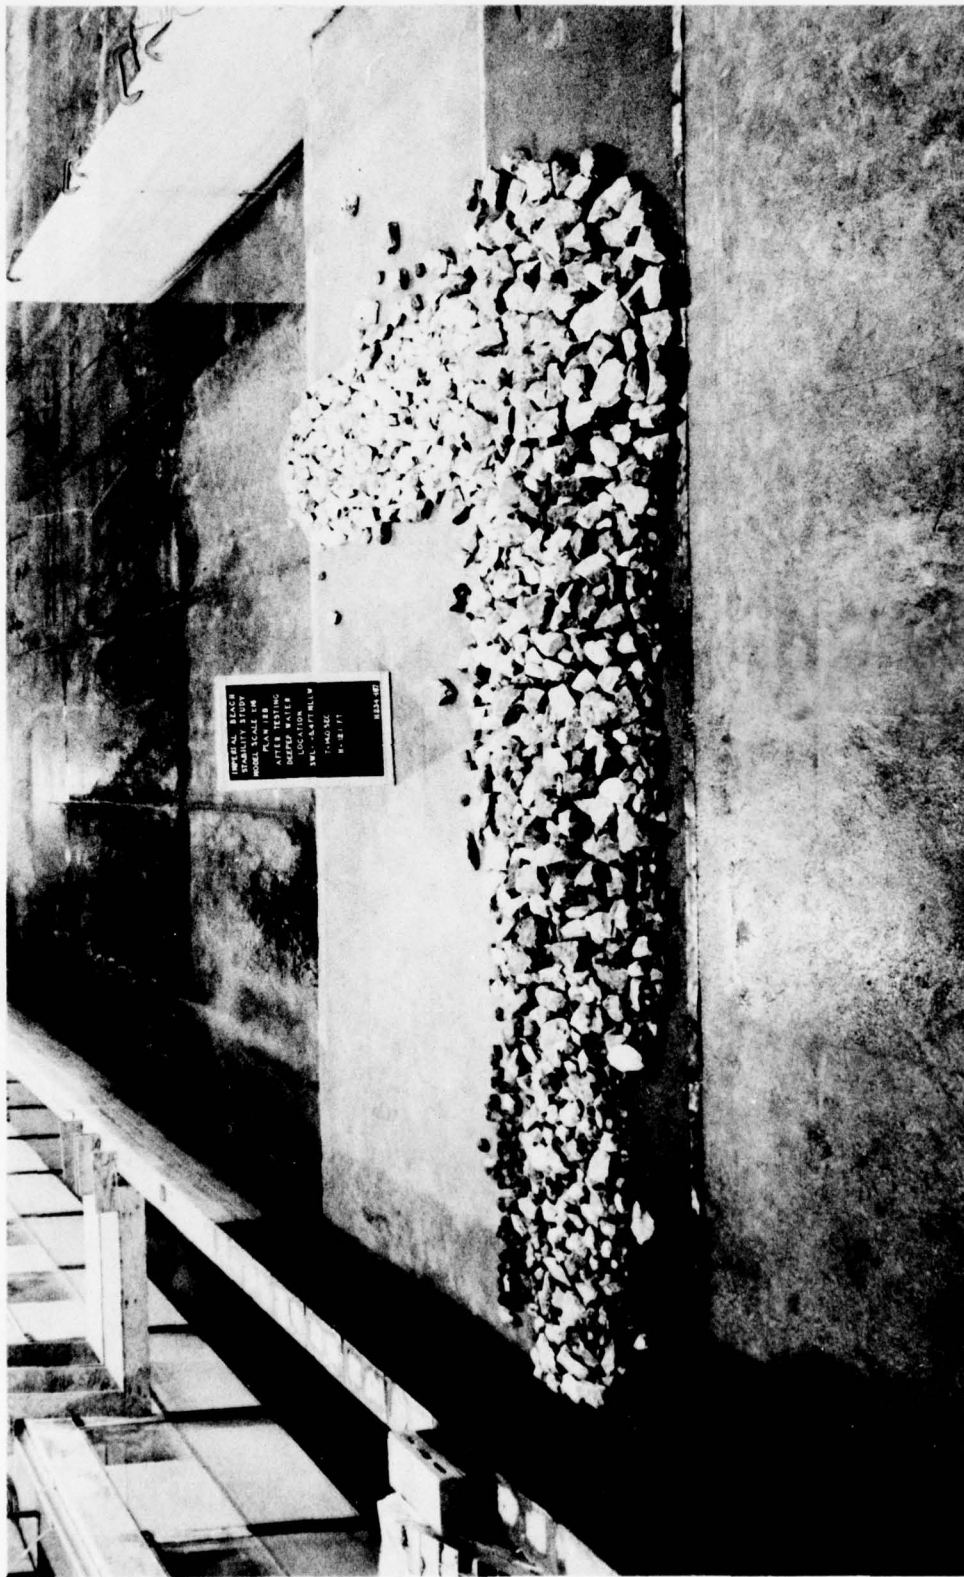
Photo 71. Sea-side view of Plan 12B in the deeper water location after 2.0 hr on high-sill head and 10-ft-high groin and 8.0 hr on remainder of breakwater of 14.0-sec, 12.1-ft waves at an swl of +5.4 ft mllw

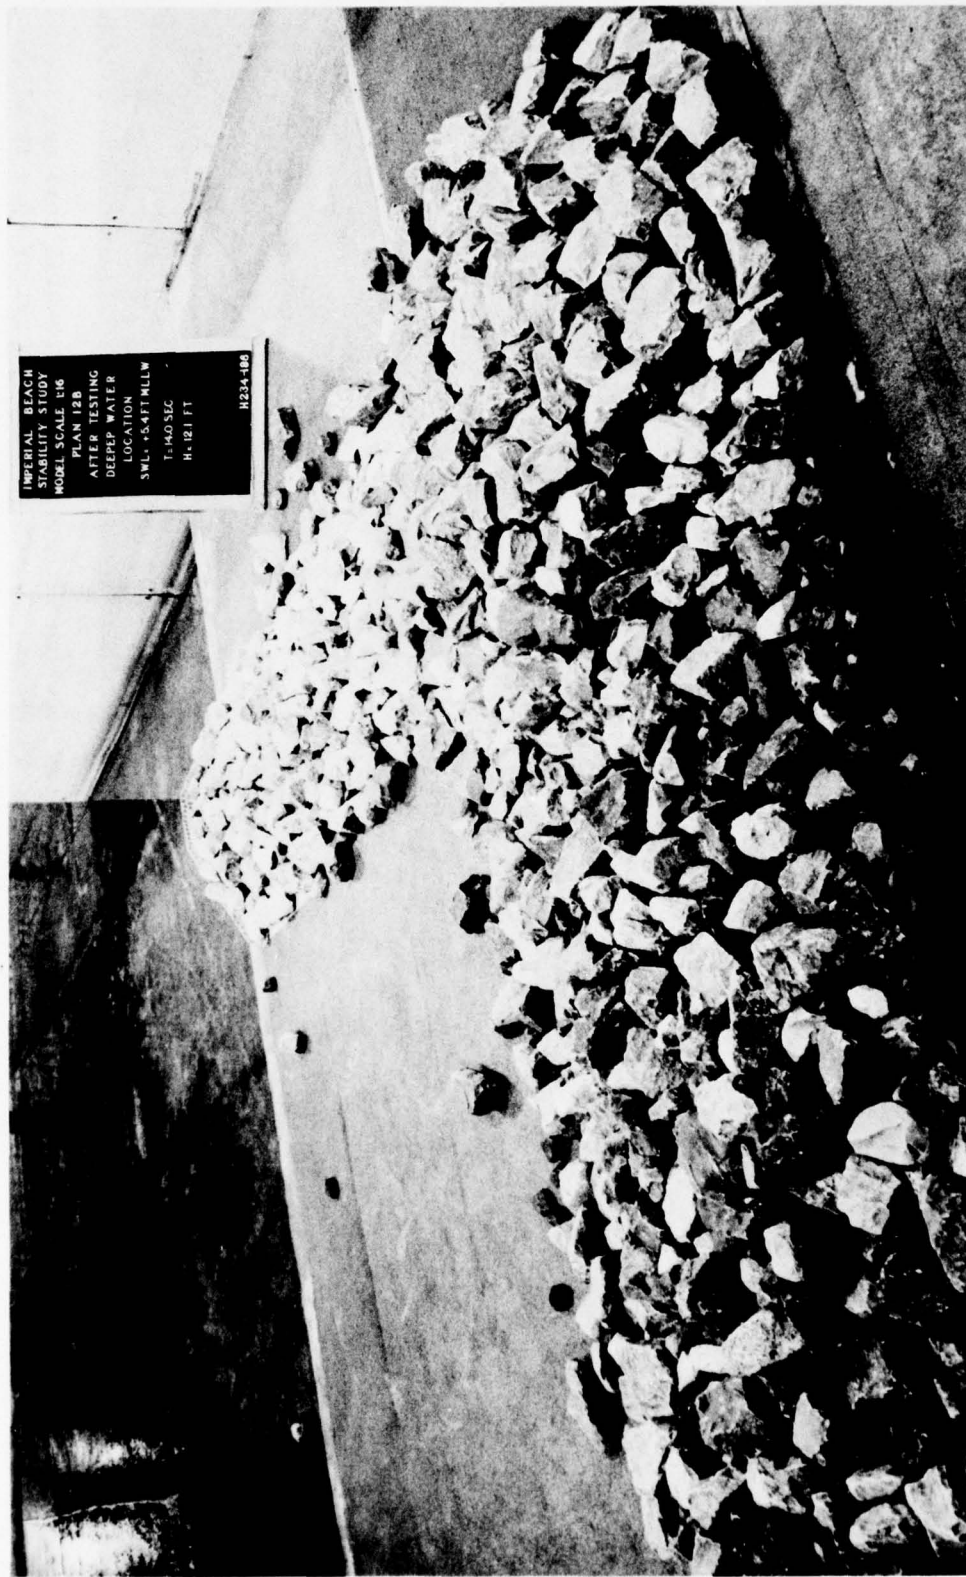
Photo 72. Sea-side view of high-sill section and 10-ft-high groin of Plan 12B in the deeper water location after 2.0 hr on high-sill head and groin and 8.0 hr on remainder of high-sill of 14.0-sec, 12.1-ft waves at an swl of +5.4 ft mllw

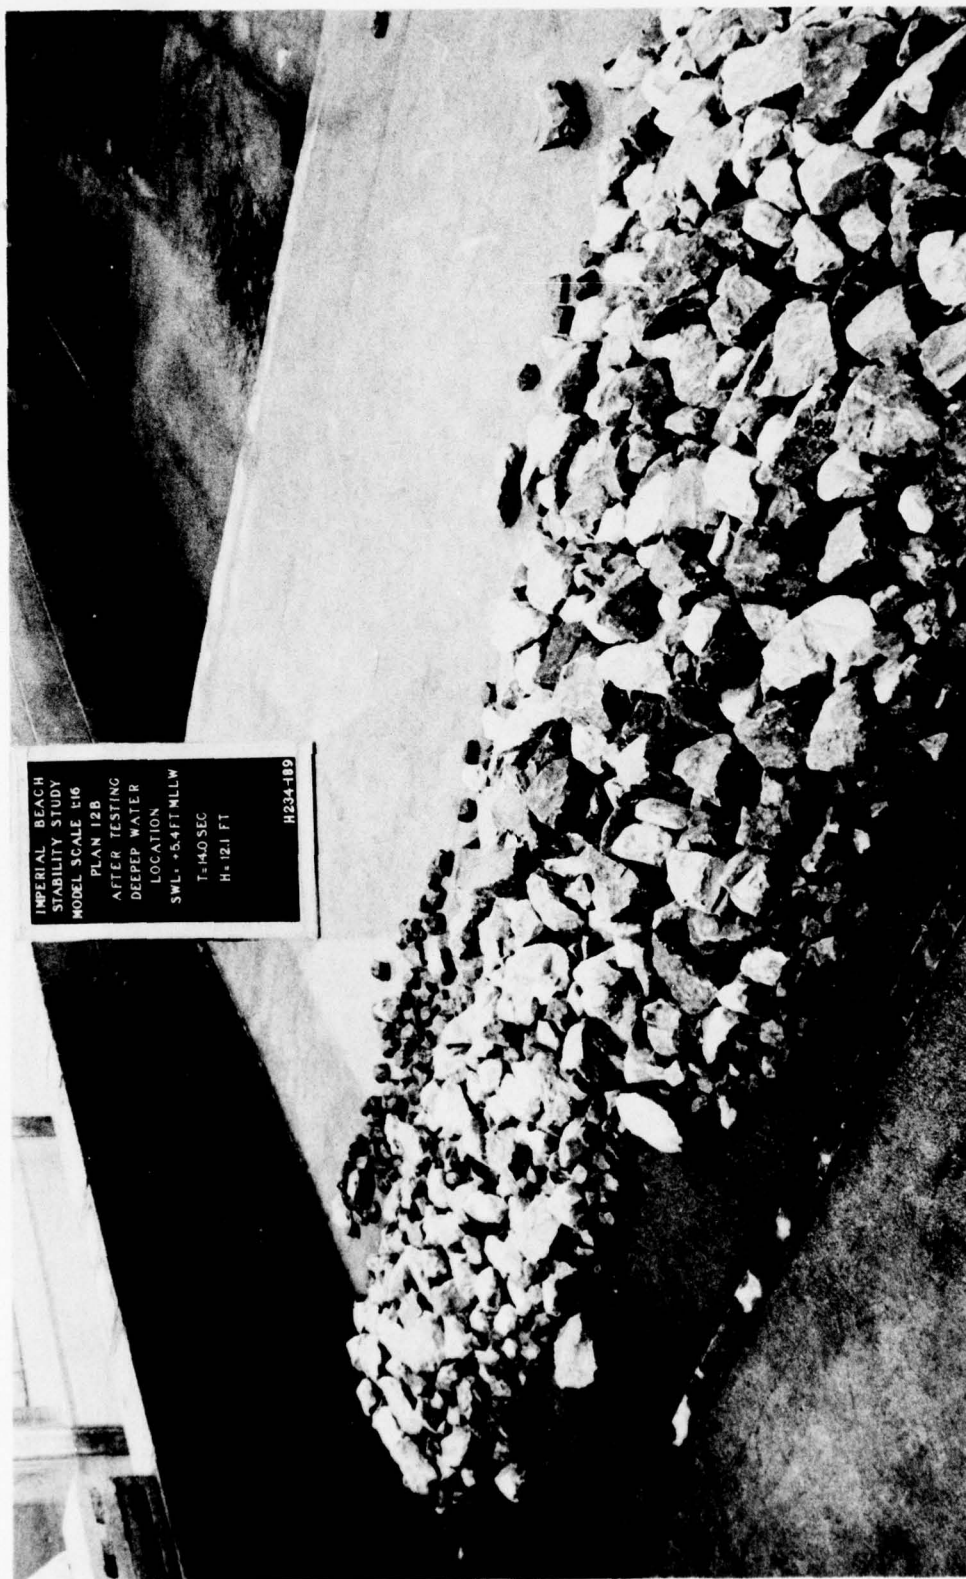
Photo 73. Sea-side view of low-sill section of Plan 12B in the deeper water location after 8.0 hr of 14.0-sec, 12.1-ft waves at an swl of +5.4 ft mllw

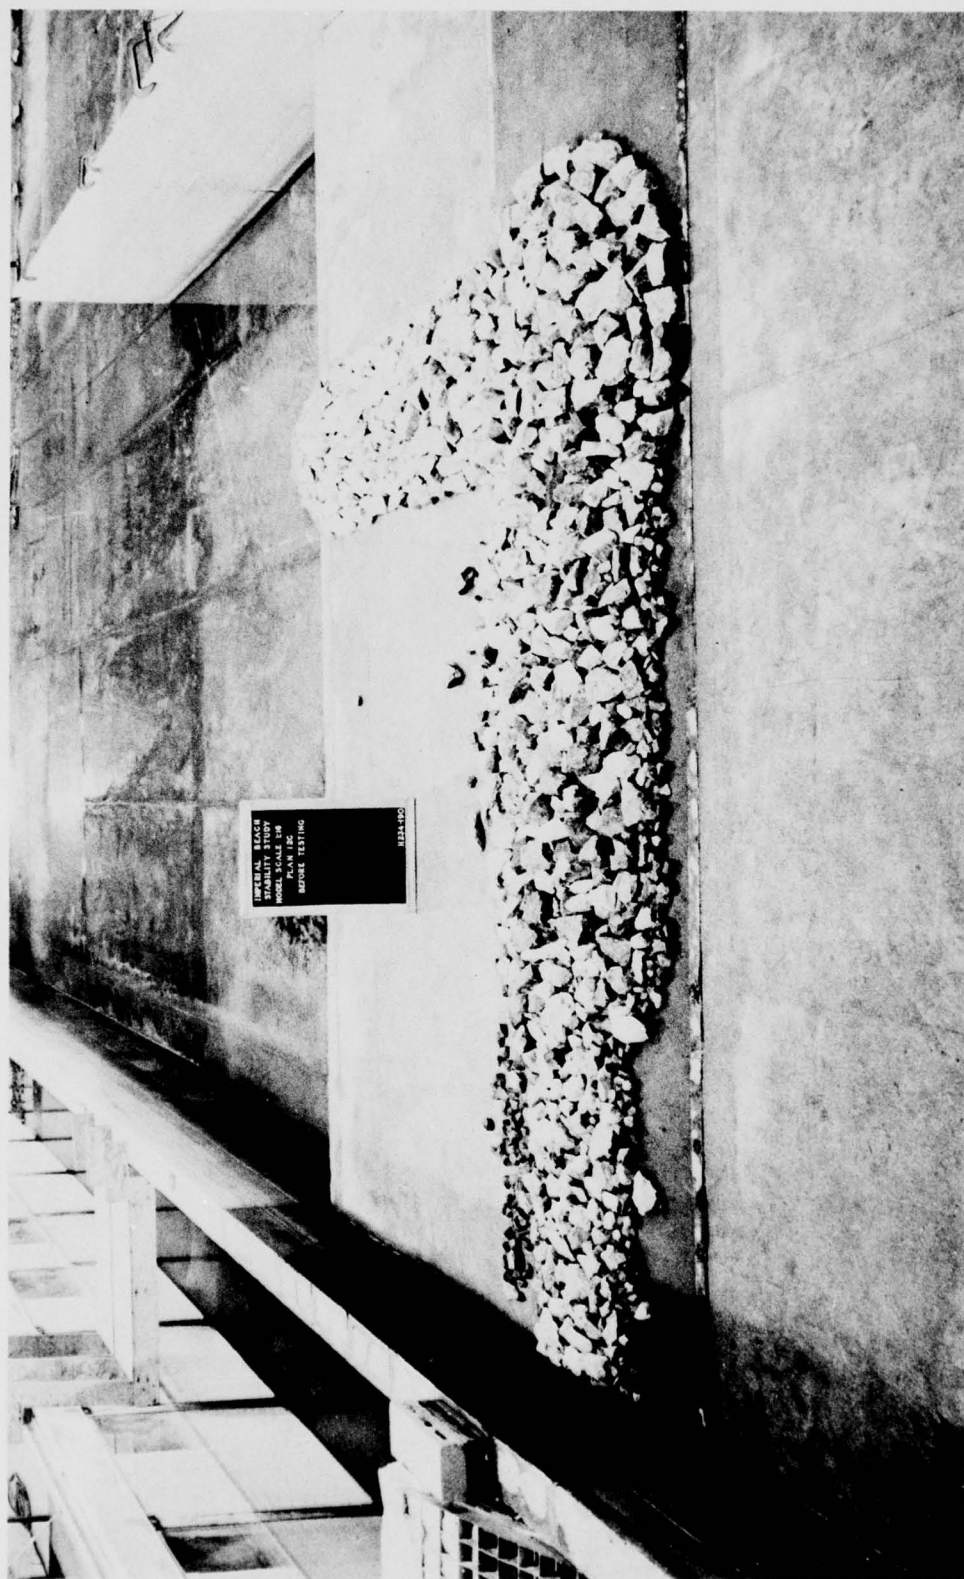
Photo 74. Sea-side view of Plan 12C before wave attack

31. Plan 12C (Plate 20 and Photos 74 and 75) was identical with Plan 12B except that the first 40 ft of the 10-ft-high groin adjacent to the high-sill head was capped with one layer of 7.0-ton armor stone. Like Plans 12A and 12B, the high-sill head was rebuilt, but the remainder of the breakwater was not. The breakwater was then exposed to 2.0 hr of 14.0-sec, 12.1-ft waves at an swl of +5.4 ft mllw. At the conclusion of the test all damage had stabilized. Minor damage had occurred on the high-sill head and groin. The high- and low-sill trunk sections had been exposed for a total of 10.0 hr to 14.0-sec, 12.1-ft waves at an swl

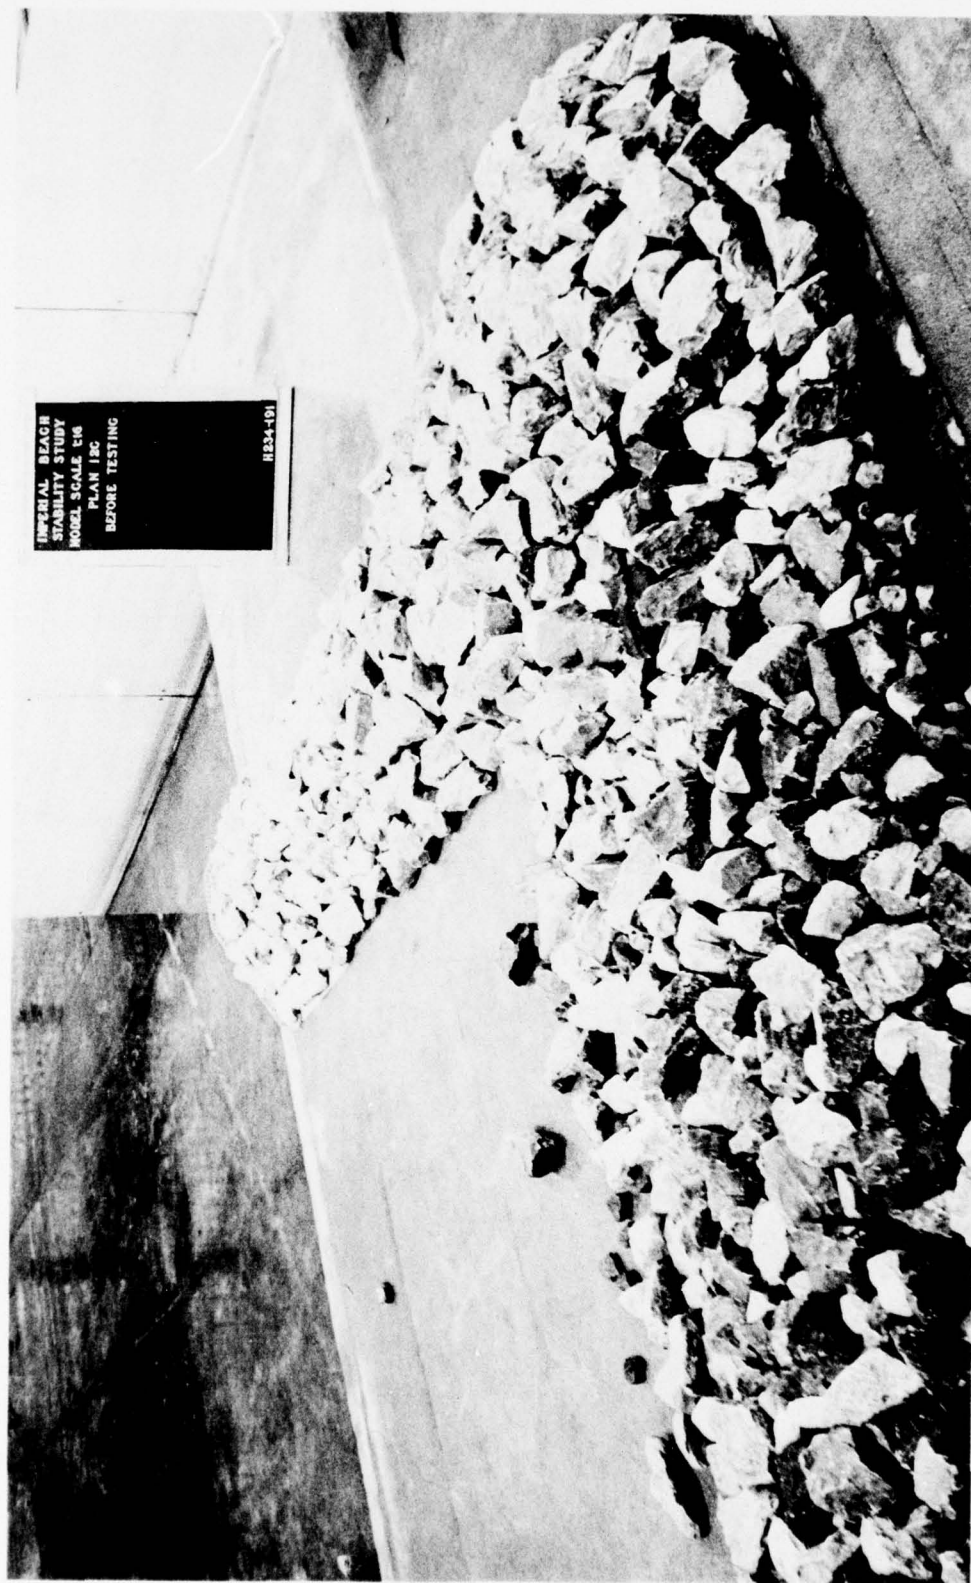
Photo 75. Sea-side view of high-sill section and 10-ft-high groin of Plan 12C before wave attack; groin modified and rebuilt and only high-sill head of remaining breakwater rebuilt in changing from Plan 12B to Plan 12C

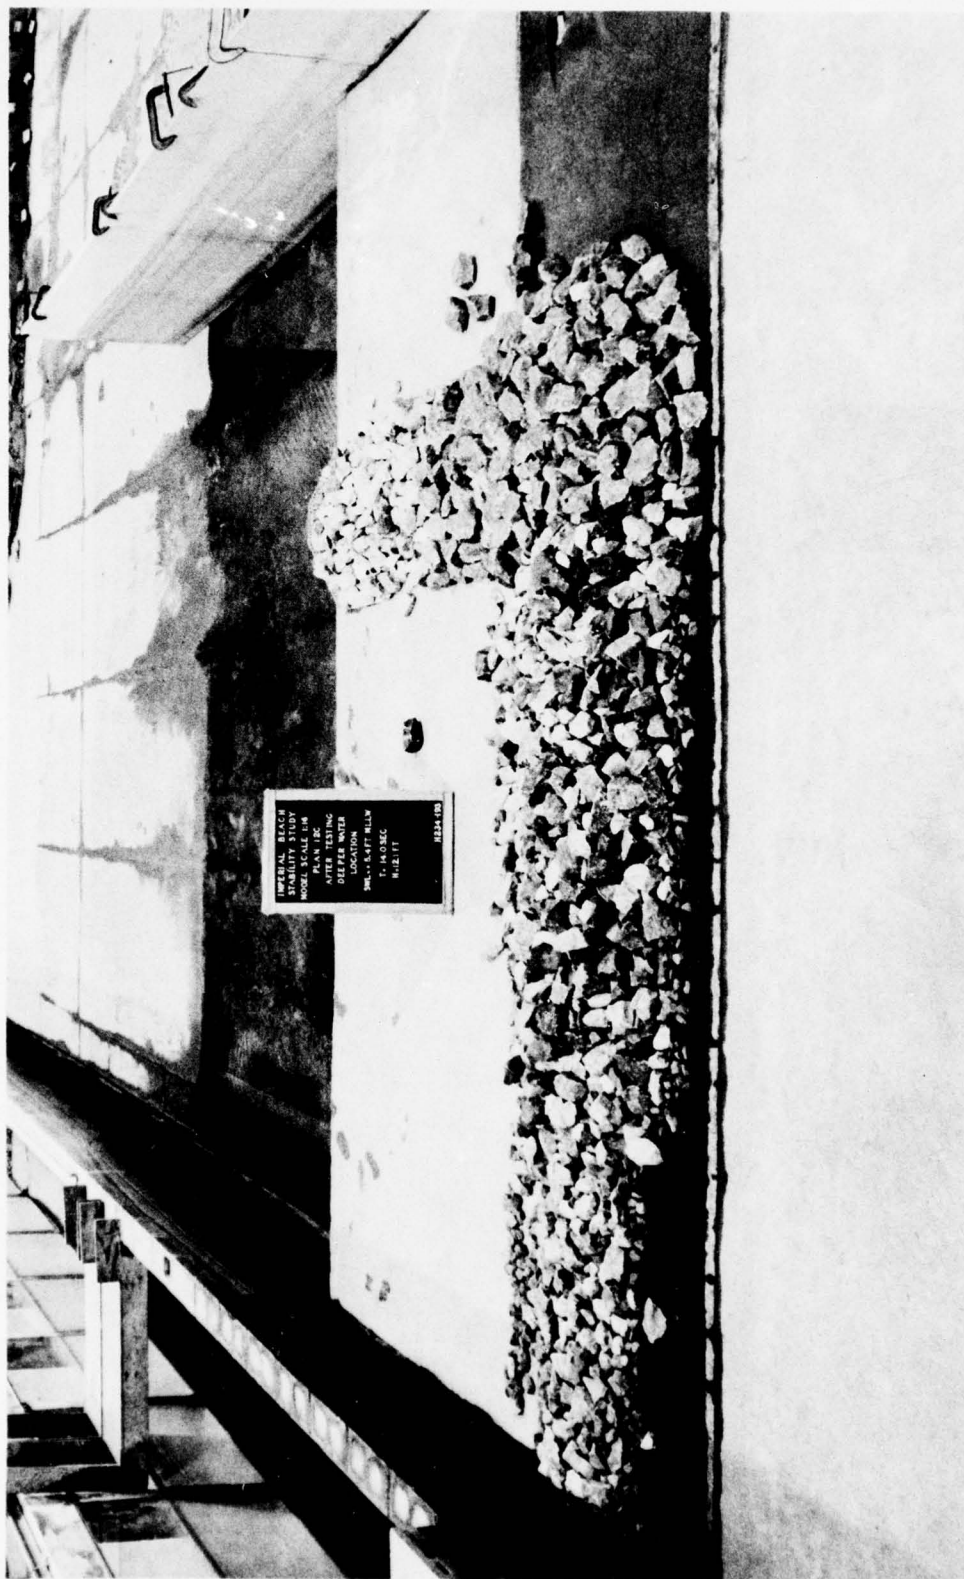
Photo 76. Sea-side view of Plan 12C in the deeper water location after 2.0 hr on high-sill head and 10-ft-high groin and 10.0 hr on remainder of breakwater of 14.0-sec, 12.1-ft waves at an swl of +5.4 ft mllw

of +5.4 ft mllw since its initial building and had sustained minor to moderate damage (Photos 76-78).

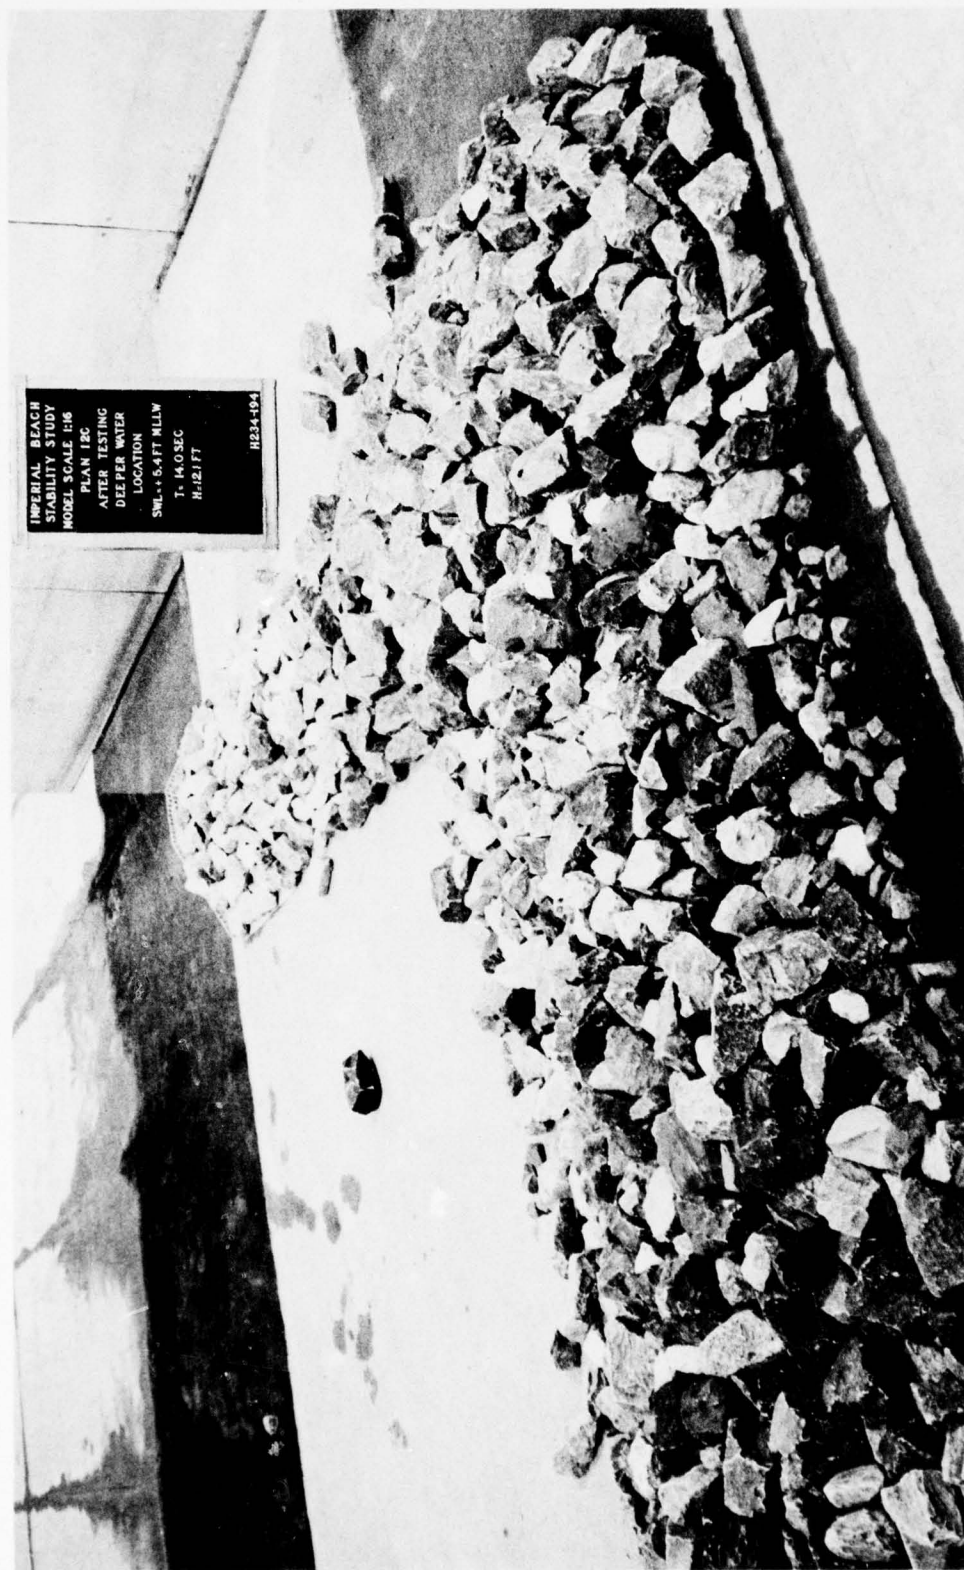
Photo 77. Sea-side view of high-sill section and 10-ft-high groin of Plan 12C in the deeper water location after 2.0 hr on high-sill head and groin and 10.0 hr on remainder of high-sill of 14.0-sec, 12.1-ft waves at an swl of +5.4 ft mllw
